# Nor848A Acoustic camera

## Filming Breakout Noise from Café and Concert Venue

### Measurements in bar and bistro Oslo, Norway, March 2016

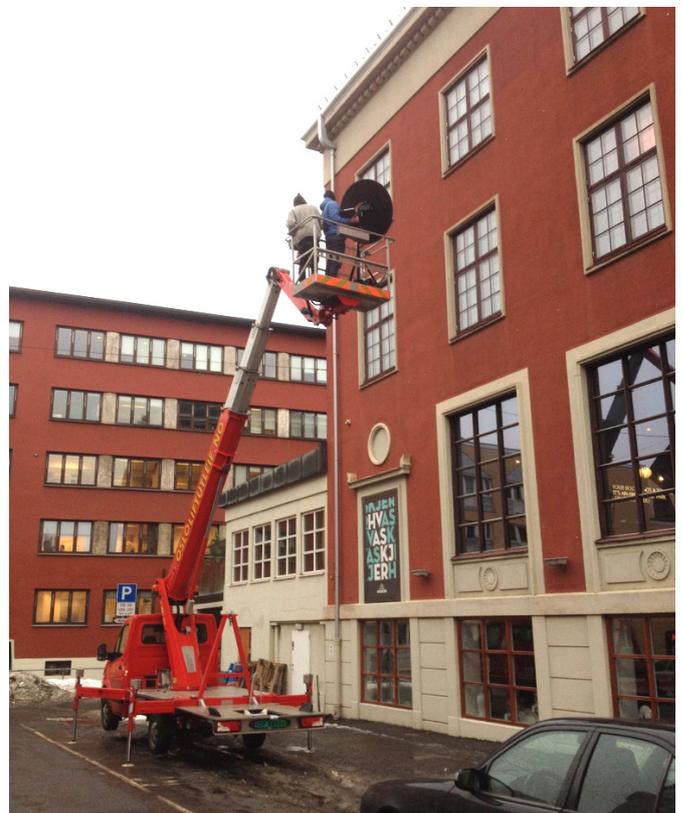
The 1.0 m Nor848A-10 with 256 microphones was used for the recordings. The camera was plugged into an

external battery pack for easy transportation and mobility. In addition to measuring the wall and windows of the concert venue, a wall between the café and a patio area on the ground floor was also of interest.

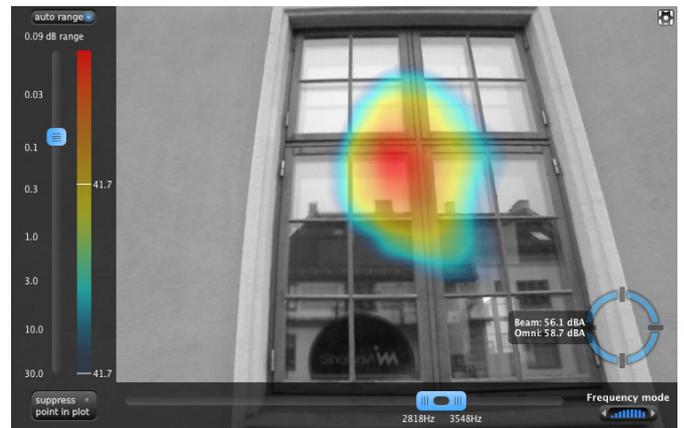
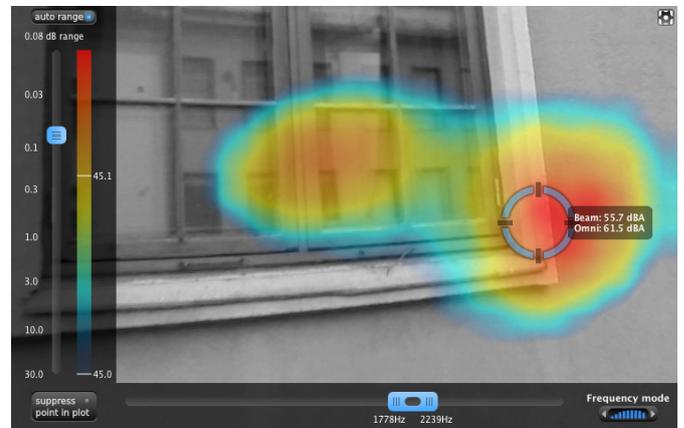
Seen in the pictures below are some of the measurements of the concert venue facade. As can be seen one could quickly rule out that any additional measures had to be taken on the wall itself, as the only sound leakage that could be seen came from the windows only. It was also possible

to zoom in on different areas of interest, either at the site during a measurement, or at a later time in post-processing analysis to further locate weak spots.

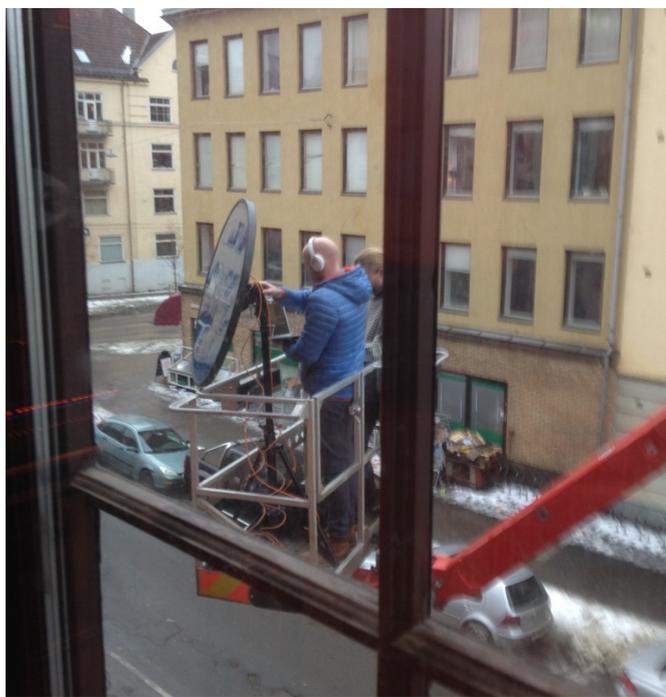
The camera was placed outside pointing at the facade of interest, with the audio system inside of the music venue playing white noise at volumes up to 100 dBA. The room inside would then act as a sending room, and the outside as the receiving room. In order to get close enough to the windows of the concert venue, a truck mounted crane was hired, with both camera and operator around 7 m above ground during measurements.

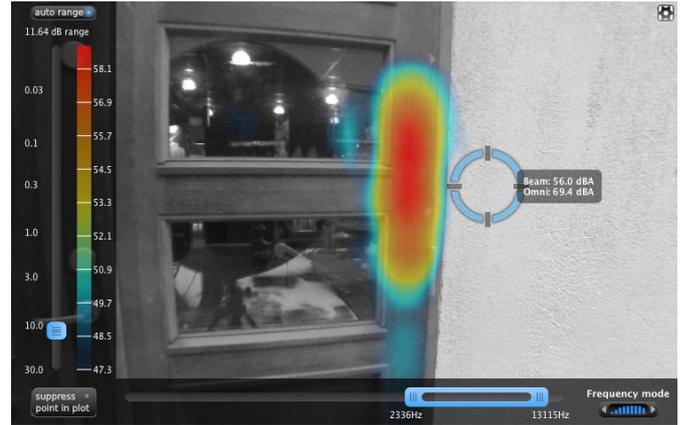
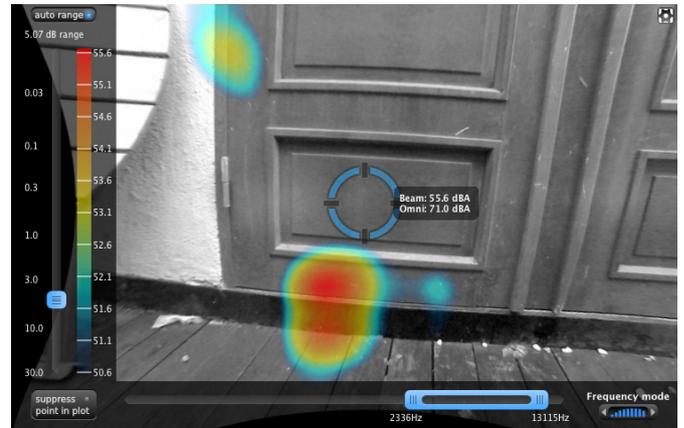
The second measurements were conducted on the patio outside the café on the ground floor. Here the measurement conditions were substantially easier, as the patio was shielded from the city traffic noise. Again the music system of the café emitting white noise was used as source. The wall between the café leading to the patio consists of both a door and several windows. The first step consisted in seeing what made the biggest noise contribution. As seen in the image below, where the dynamic range is set to 10 dB, the door had a noise contribution that was approximately 10 dB higher than the nearest window.
